**WISCONSIN TRAFFIC OPERATIONS
& SAFETY LABORATORY**
UNIVERSITY OF WISCONSIN-MADISON

Date: 12/29/2009
To: Marie Treazise, WisDOT Bureau of Highway Operations
From: Amanda Ryadi, Wisconsin TOPS Lab
Subject: Ramp Metering Evaluation – Technical Memo #6
Crash Evaluation

This memorandum summarizes the crash evaluation for metering locations on highways around the Milwaukee and Madison areas. The crash data used are combined data from two sources: the state trunk network (STN) GIS crash maps and the WisTransPortal MV4000 Crash Database. Each source has some information that the other does not.

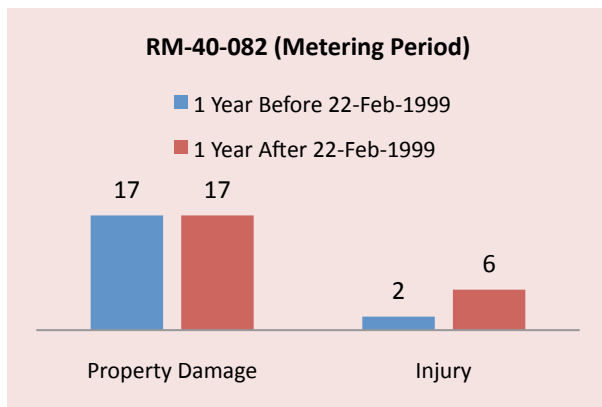
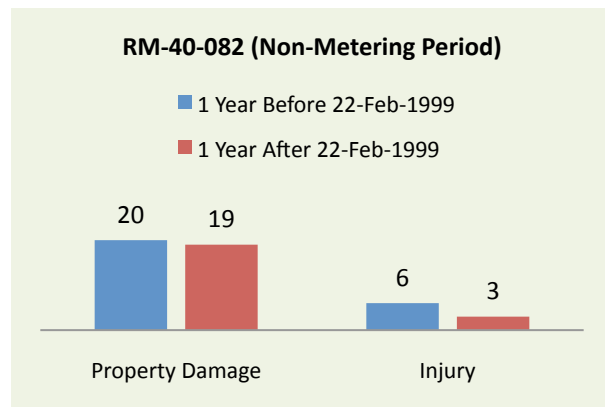
RM-40-082 Before and After Crash Analysis (Non-Metered)

During the metering period, there is no change in property damage related incidents after the installation of RM-40-082, but injury related incidents increased by 200%. During the non-metering period, property damage related incidents decrease by 5% after the installation and injury related incidents decreased by 50%. This shows that RM-40-082 was likely ineffective in reducing the number of crashes.

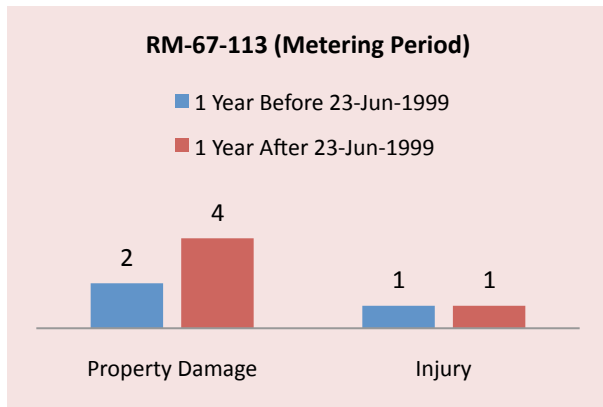
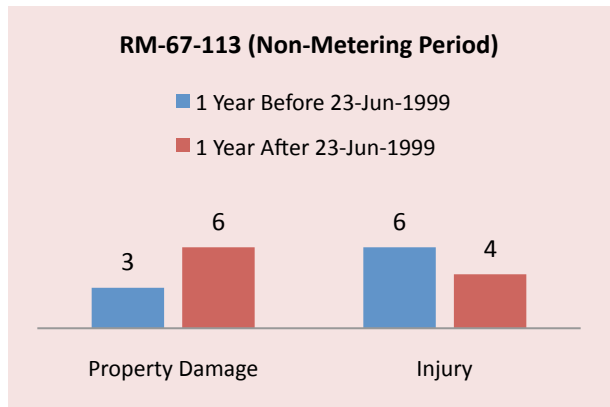
RM-67-113, I-94 WB @ Hwy T (Grandview)

During the metering period, there was no change in injury related incidents after the installation of RM-67-113, but the property damage related incidents increase by 100%. During the non-metering period, the property damage related incidents increase by 100% after the installation, but the injury related incidents decreased by 33%. This shows that RM-67-113 was likely ineffective in reducing the number of crashes.

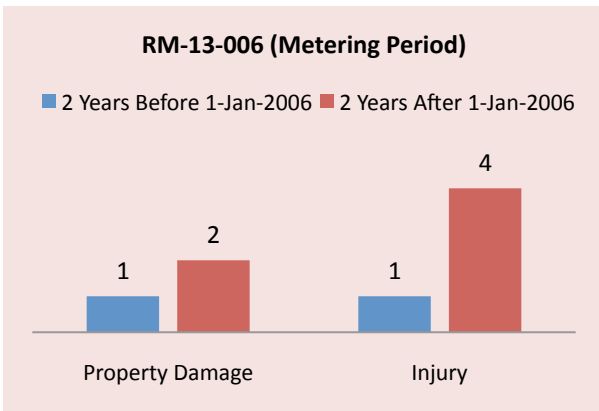
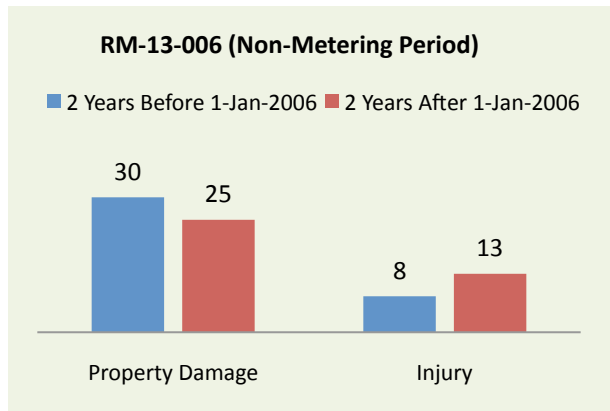
RM-13-006, US 12 Westbound @ Todd Drive (Madison)

During the metering periods, the property damage related incidents increase by 100% after the installation of RM-13-006 and the injury related incidents increase by 300%. During the non-metering periods, the property damage related incidents decrease by 17% after the installation, but the injury related incidents increase by 63%. This shows that RM-13-006 was likely ineffective in improving safety.

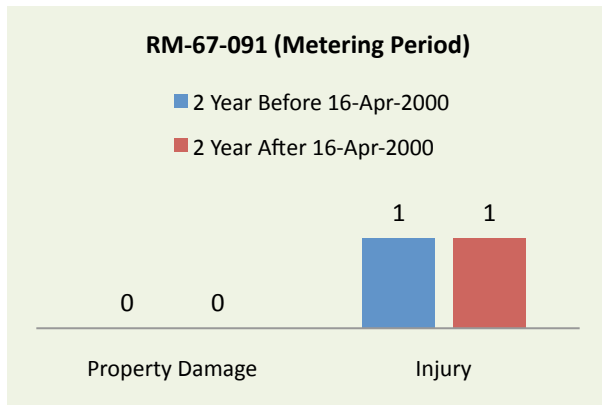
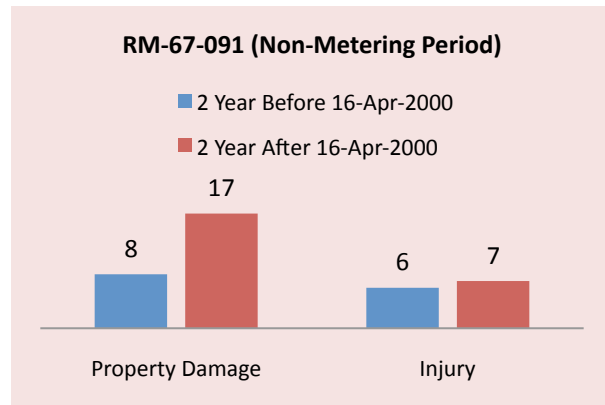
RM-67-091, US 45 SB @ County Line Rd

During the metering period, there was no change in property damage related incidents and injury related incidents. During the non-metering period, the property damage incidents increased by 113% after the installation of RM-67-091 and the injury related incidents increased by 17%. This shows that RM-67-091 was likely ineffective in improving safety.

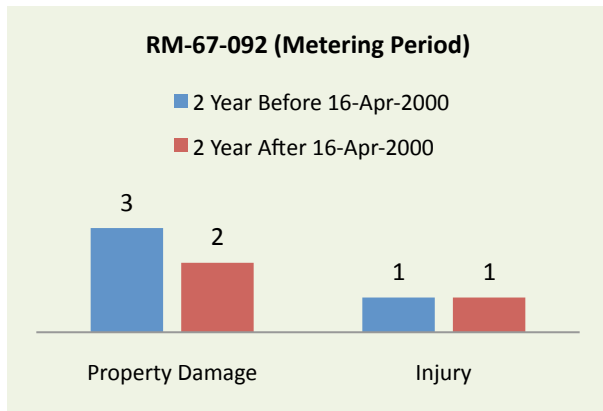
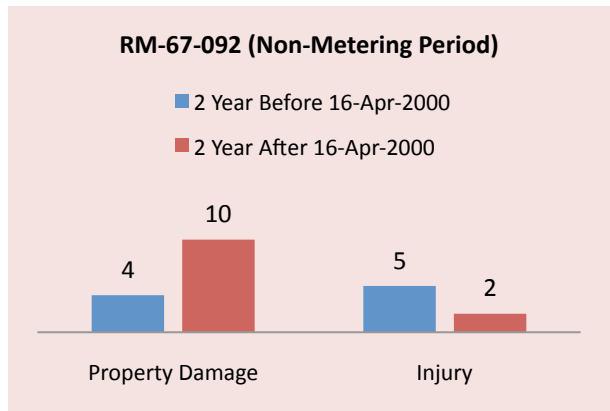
During the metering periods, there was no change in injury related incidents after the installation of RM-67-092, but the property damage incidents decreased by 33%. During the non-metering period, the property damage related incidents increase by 150% after the installation, but the injury related incidents decrease by 60%. This shows that RM-67-092 may have been effective in improving safety.

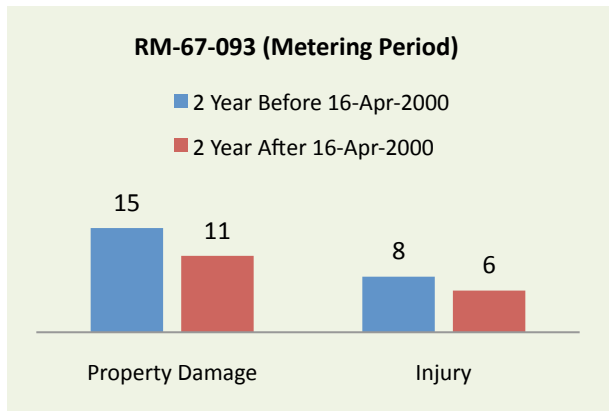
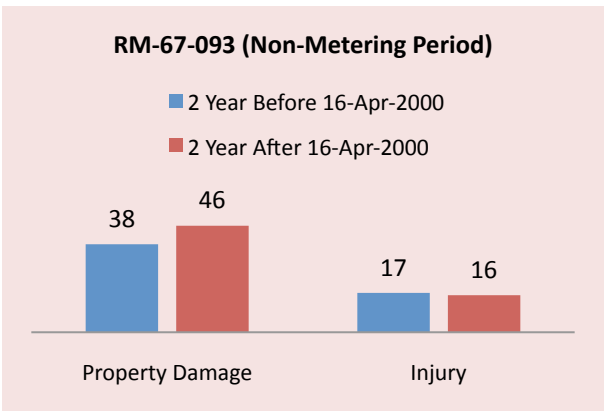
RM-67-093, US 45 SB @ Hwy 74 (Main St)

During the metering period, the property damage related incidents increased by 27% after the installation of RM-67-093 and the injury related incidents increased by 25%. During the non-metering period, the property damage related incidents increase by 21%, but the injury related incidents decrease by 6%. This shows that RM-67-093 was likely effective in improving safety.

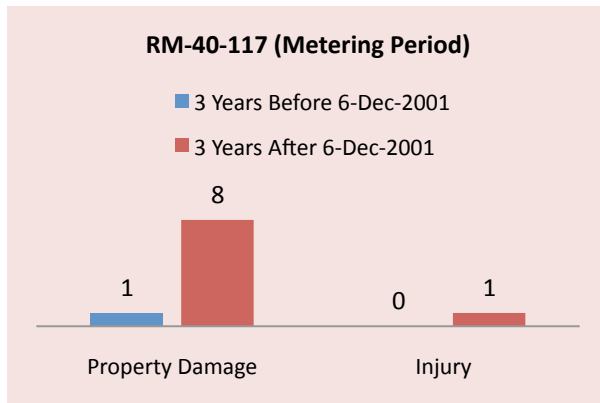
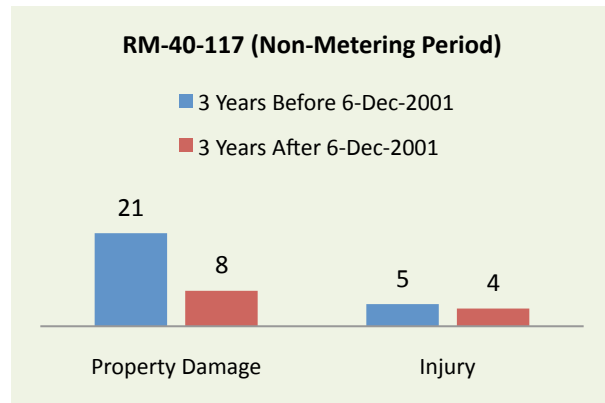
During the metering period, the property damage related incidents increase by 700% after the installation of RM-40-117 and the injury related incidents increased from none to one in the three years that followed. During the non-metering period, the property damage related incidents decreased by 62% and the injury related incidents decrease by 20%. This shows that RM-40-117 was likely ineffective in improving safety.

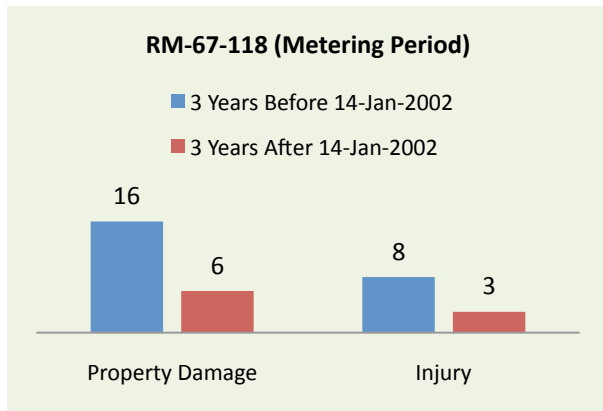
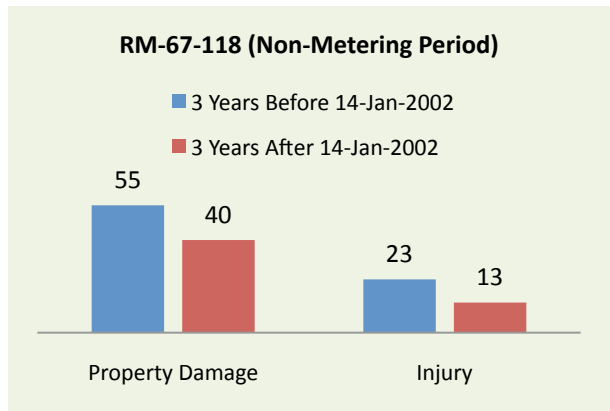
RM-67-118, US 45 NB @ Main St

During the metering period, the property damage related incidents and injury related incidents decrease by 63% after the installation of RM-67-118. During the non-metering periods, the property damage related incidents decreased by 27% and the injury related incidents decreased by 44%. This shows that the installation of RM-67-118 was likely effective in improving safety.

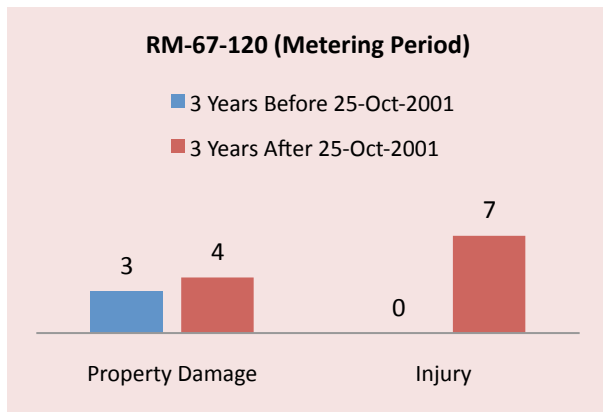
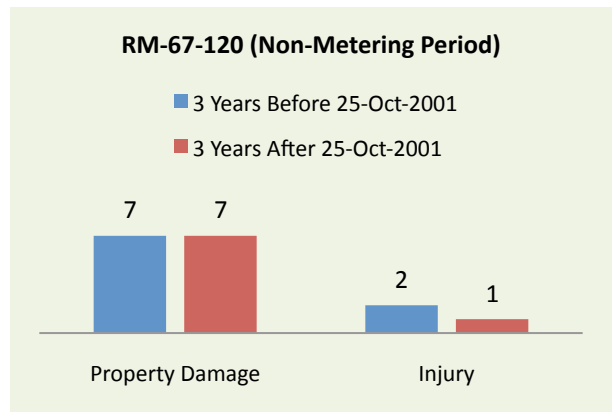
RM-67-120, I-94 WB @ Hwy G

During the metering period, the property damage related incidents increased by 33% after the installation of RM-67-120 and the injury related incidents increased from none to seven crashes in three years.. During the non-metering period, there is no change in the property damage related incidents, but the injury related incidents decrease by 50%. This shows that RM-67-120 was likely ineffective in improving safety.

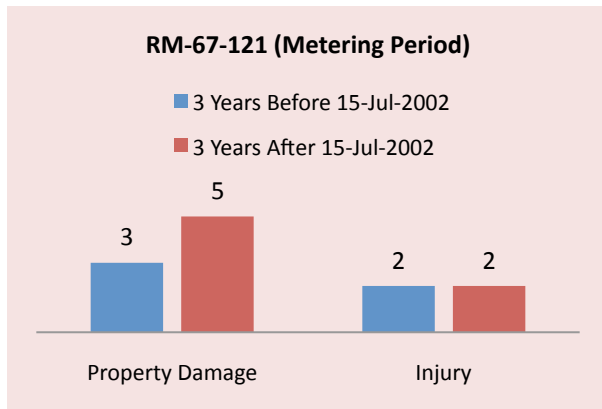
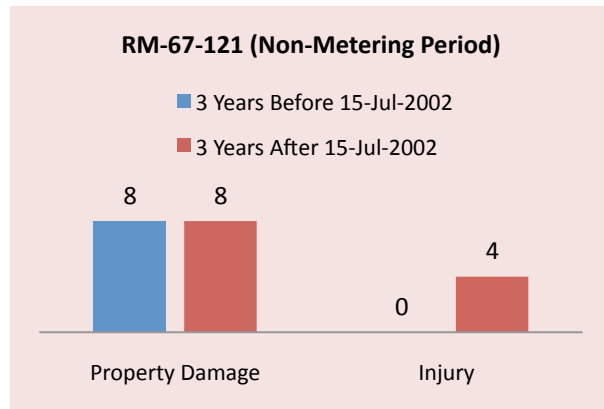
RM-67-121, I-94 EB @ Hwy G

During the metering period, there is no change in the injury related incidents after the installation of RM-67-121, but the property damage related incidents increased by 67%. During the non-metering period, there is no change in property damage related incidents, but the injury related incidents increased from none to four crashes in three years. This shows that RM-67-121 was likely ineffective in improving safety.
